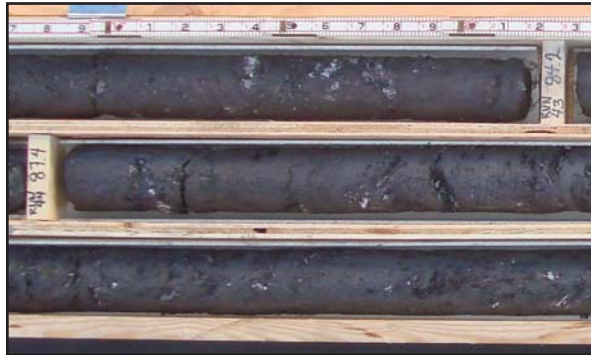
**Picture 1:**  
Typical core of Mélangé Matrix, as recovered in the field.

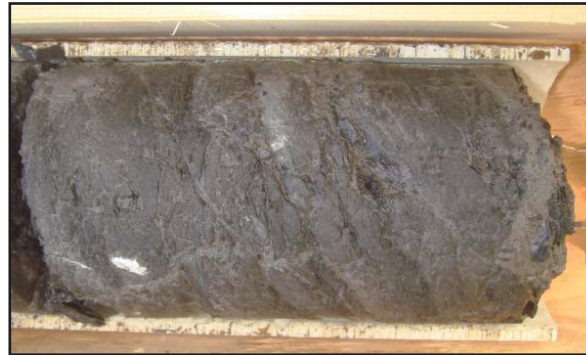
**Picture 2:**  
Close-up view of core recovered from borehole LB-03.

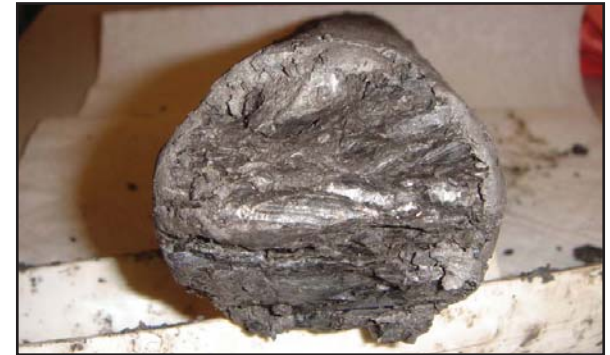
**Picture 3:**  
View of core cross-section illustrating irregular contacts between different materials, and laminated structure.

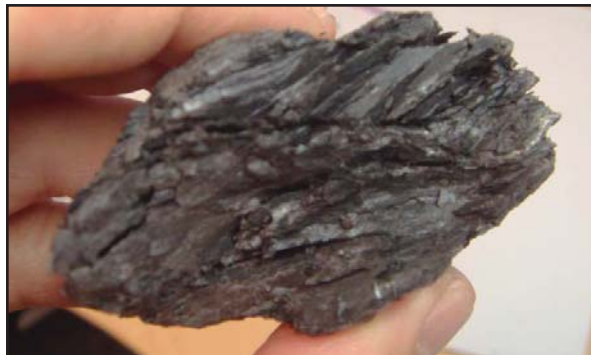
**Picture 4:**  
Close-up view illustrating contorted and laminated structure.

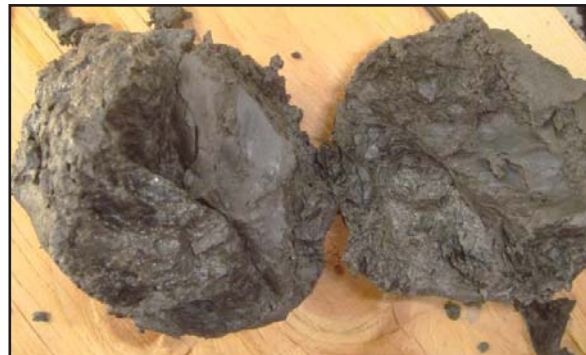
**Picture 5:**  
Close-up view illustrating evidence of shear deformations and slickensides.

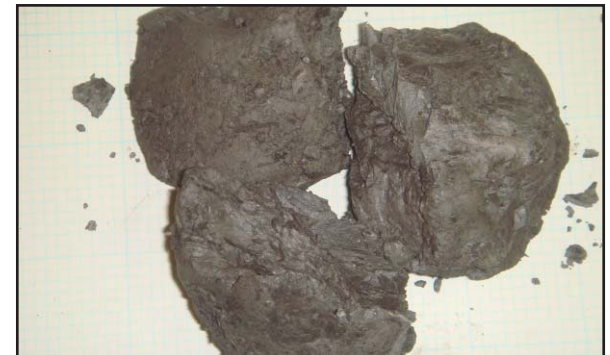
**Picture 6:**  
Close-up view that shows the presence of slickensides.
