FIG_163: Development of Lateral Deformations with Time: Hamilton Wetlands Test Fill

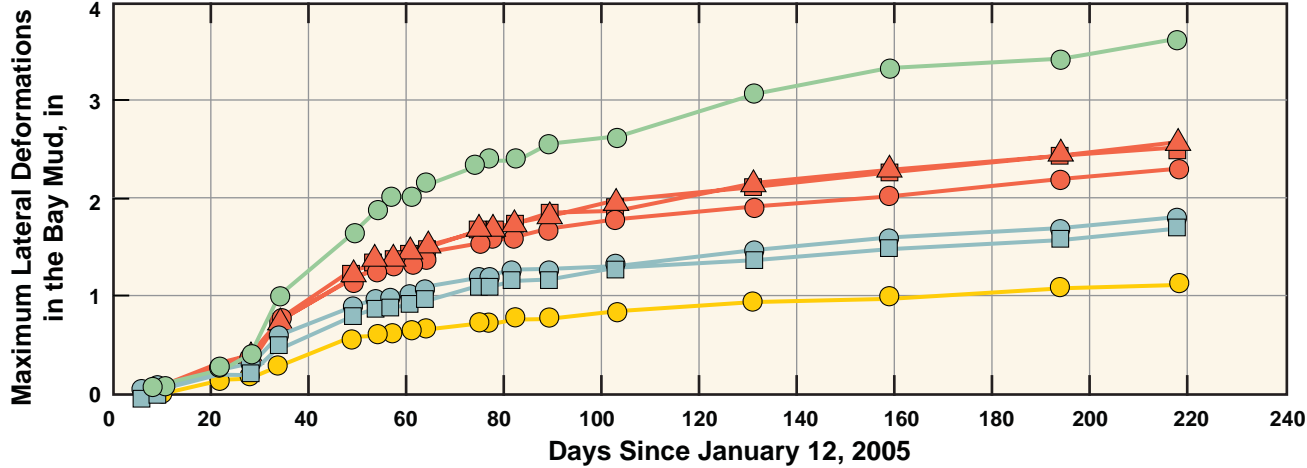
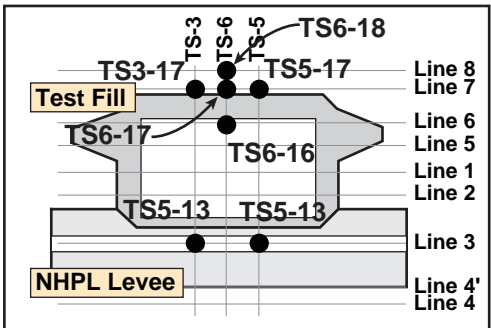
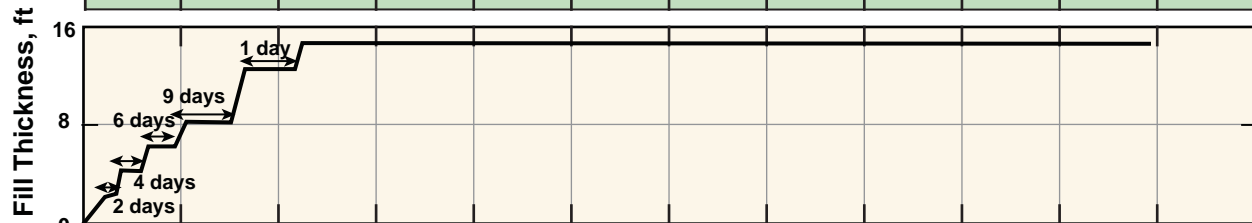
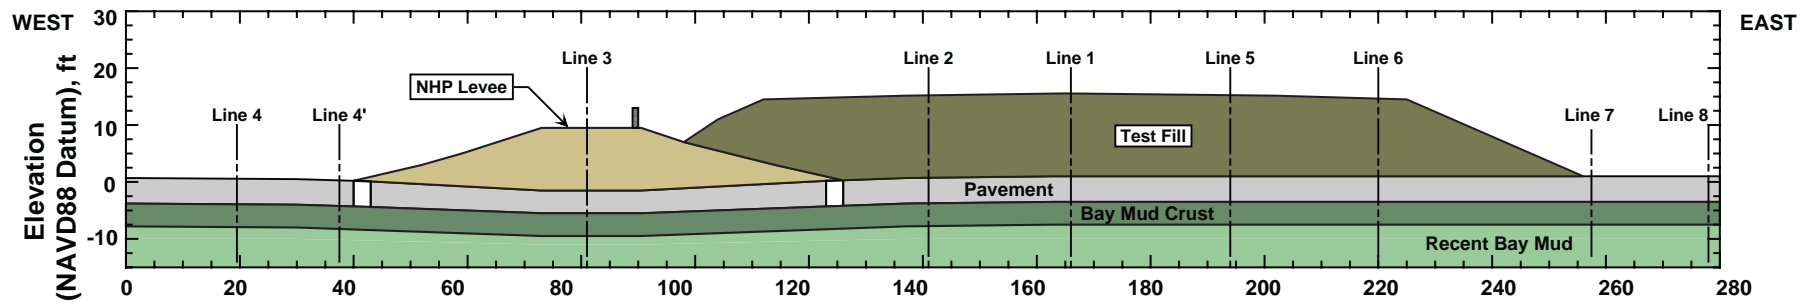
Symbol	Inclinometer No.	Line No.
●	TS3-13	3
■	TS5-13	
●	TS6-16	6
●	TS3-17	7
▲	TS5-17	
■	TS6-17	
●	TS6-18	8
